PROPERTY: Our Lady of Perpetual Help Mission Church (Old Adobe Mission)

LOCATION: 3817 North Brown Avenue, Scottsdale, Maricopa County

National Register of Historic Places Registration Form

Historic name: Our Lady of Perpetual Help Mission Church

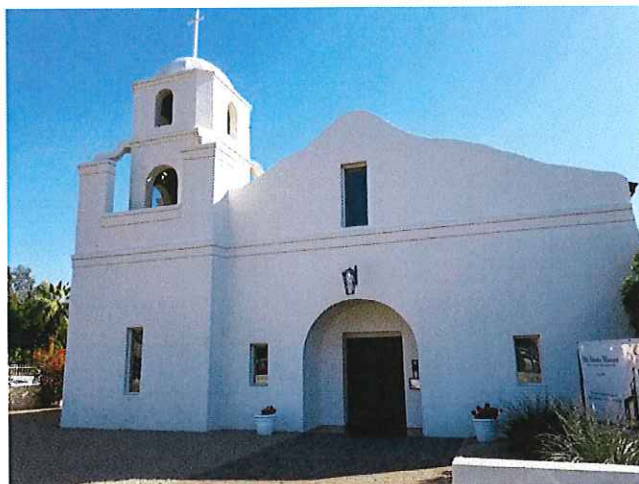
Figure 1: OLPH Mission Church, west façade. Source: Masinelli, 2018.

The OLPH Mission Church is a single-story rectangular plan building. The primary façade faces west and it has a medium-pitch gable roof. The building was designed in the Mission Revival style whose distinguishing characteristics include the white stuccoed exterior finish, a battered curvilinear parapet wall extending above the roofline on the west façade, and a three-story bell tower at the northwest corner topped with a dome. The bell tower rises above the sacristy room at the ground floor. Flying buttresses project from the four corners of the bell tower to provide it with structural stability. The dome is topped by a cross. A recessed round arch defines the entryway and features five-paneled, wood double doors. Also characteristic of Mission Revival are its small windows, which emphasizes the smooth white plane of the exterior surface. Windows are fixed stained glass dating to the building's construction in 1933. The original roof was cedar shake shingles, but it was updated to asphalt shingles including 12-18 inches of insulation in 2012 at the City of Scottsdale's recommendation due to the church's proximity to restaurants. A wrought iron chandelier lighting fixture extends from the wall over the front entrance.

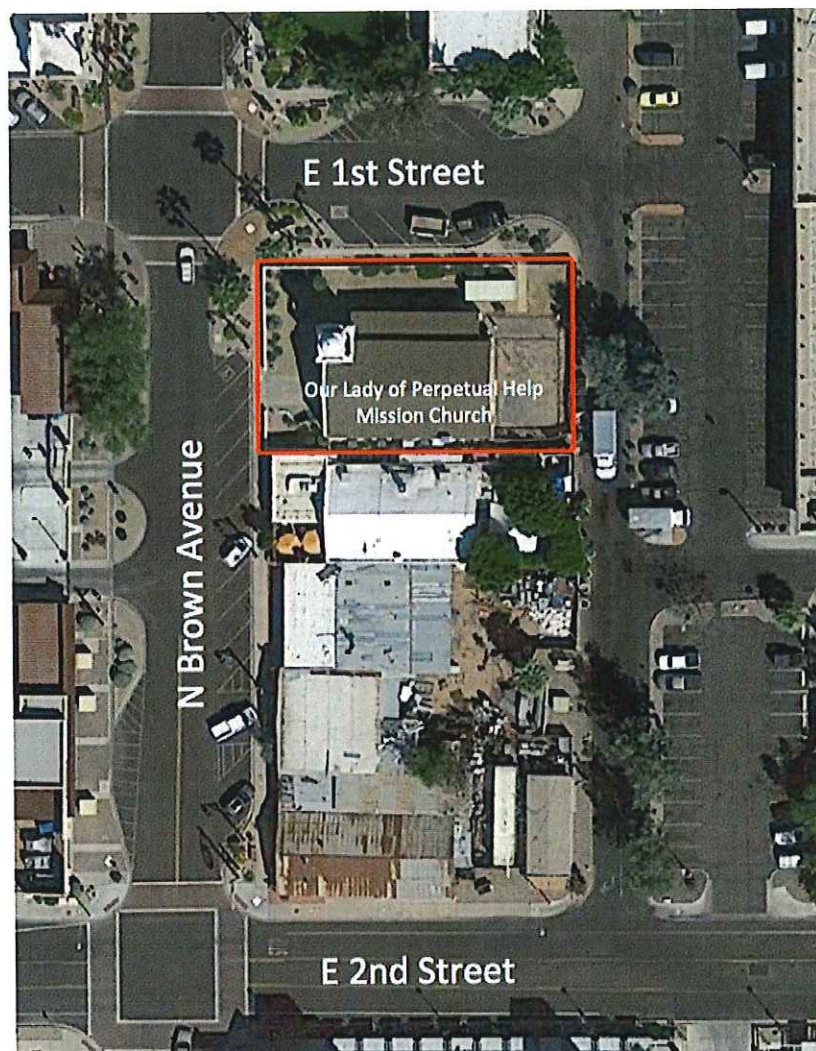
Figure 2. Aerial photograph of OLPH Mission Church. Source: Google Earth, 2016.

The Our Lady of Perpetual Help Mission Church, popularly known as the Old Adobe Mission, is located at 3817 North Brown Avenue in Scottsdale, Arizona. The building is sited on a 75 ft. by 125 ft. lot (Maricopa County parcel no. 130-23-219) at the southeast corner of Brown Avenue and 1st Street (Figure 2).

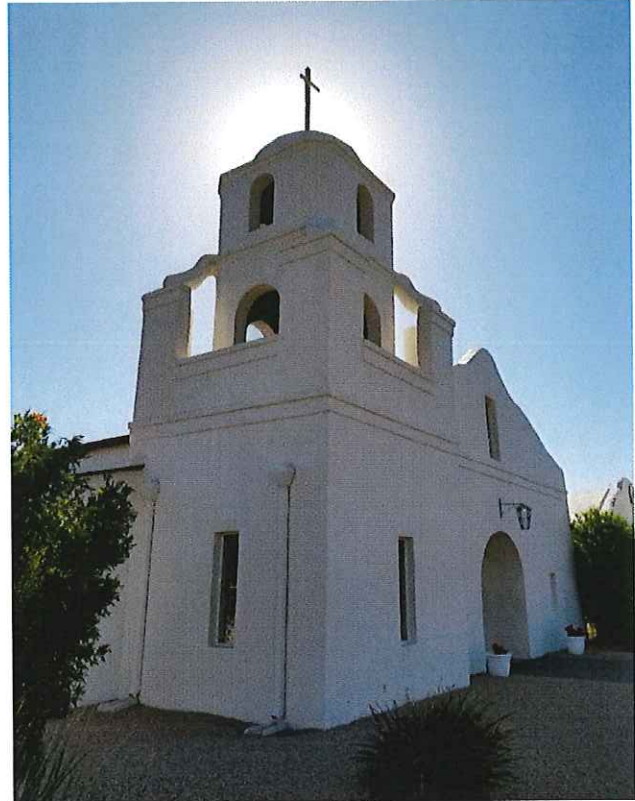
Figure 4. This southeastern view emphasizes the sacristy room at the ground floor topped by the bell tower. Focus is placed on the open-air buttresses projecting from the four corners of the bell tower providing the structure with stability. The curvilinear parapet is visible from this view. Source: Masinelli, 2018.

The north and south walls feature concrete buttresses that support the heavy timber roof framing. A four-bay arcade was constructed along the north wall adjoining the bell tower at the same time of original construction. There is a chimney that projects from the south wall and above the roof surface (though below the ridge line). Three HVAC electrical units and a FEMA-installed and sponsored fire prevention sprinkler system (1998) are located on the south side of the building, which is the least visible to the public.

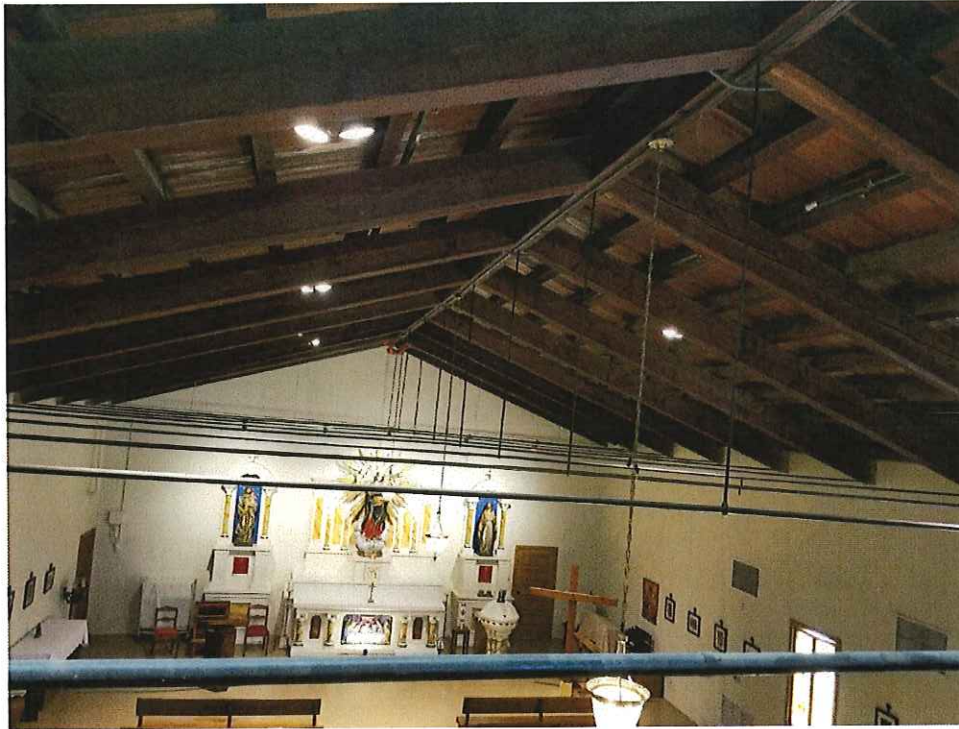
The iron bars hanging from the center support beam, eight feet apart, are the supports embedded through the wood cross beams and into the outside buttresses that enable the gabled pitched roof (Figure 5).

Figure 5. View looking east inside the church towards the altar, baptismal font, door to the Mission's Historical Museum on the right and door into the foyer/kitchen area to the left. Source: Masinelli, 2018.

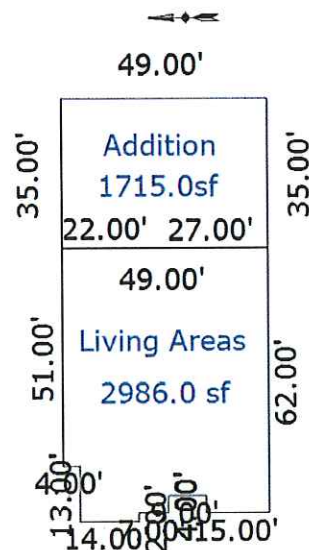
Figure 6. Building and Site Plan of the OLPH Mission including the recently completed (2017) addition.

In 2016-17, an addition was constructed on the east side of the building to provide space for Mission's historical museum, bathrooms, kitchen, conference room, and storage area. This noncontributing addition has white stuccoed walls compatible with the original mass of the building, but is distinguishable by the variation of its roof—flat with surrounding parapet—from the gable roof covering the main body of the building.

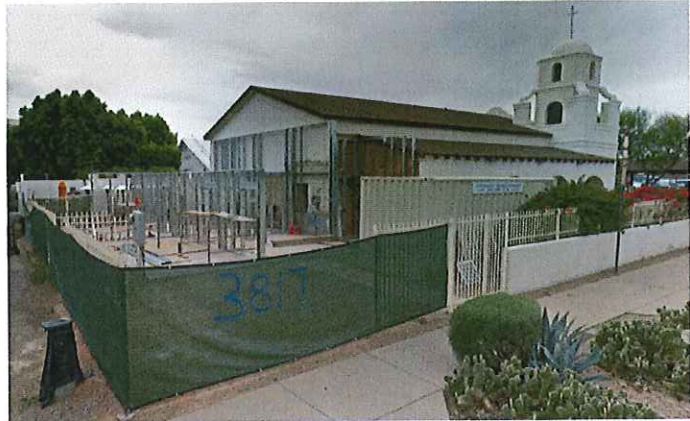
Figure 7. View facing southwest of the OLPH Mission Church during construction of the rear (east) addition showing its structural materials and connection to the original building. Source: Google, 2017.

The most substantial alteration to the building's exterior was the addition of the east side addition completed in 2017.

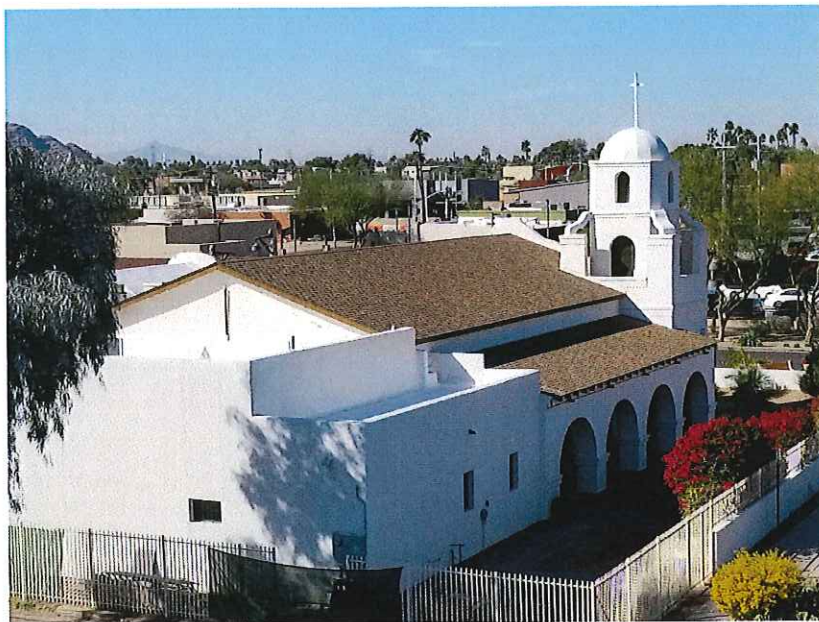
Figure 8. View of the completed addition to the rear of the OLPH Mission Church, 2017.

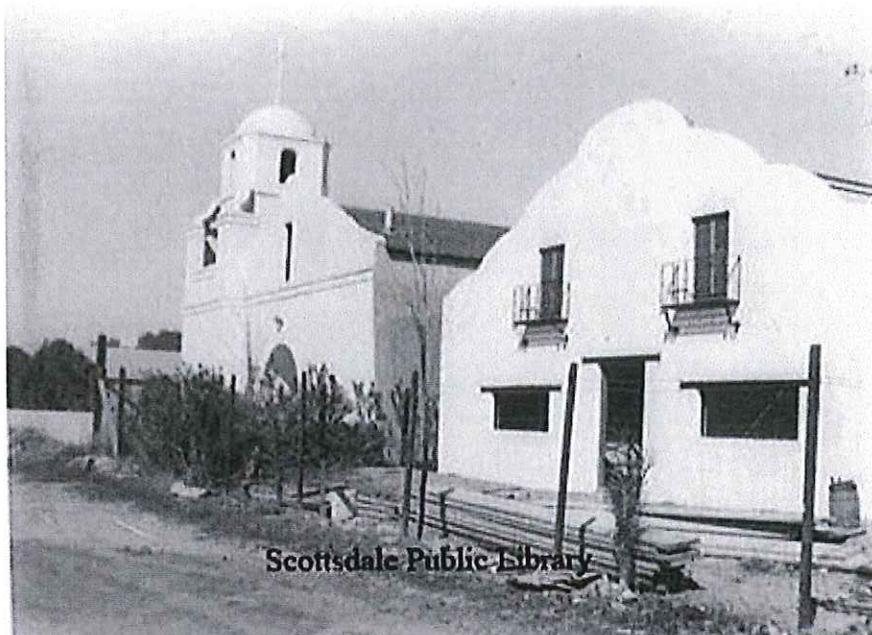
Figure 11. View of the Mission and Cavalliere Hardware and Plumbing c. 1940's. Photo courtesy of Scottsdale Public Library.

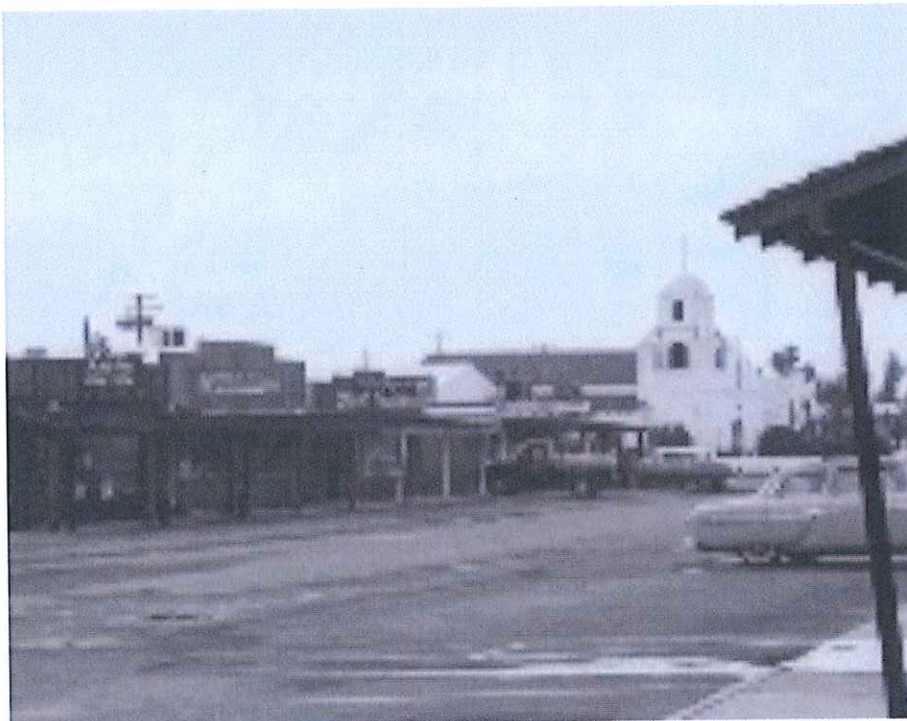
Figure 13. Southern view of the Mission on Brown Avenue from Main Street, circa 1955. Photo courtesy of Scottsdale Public Library.

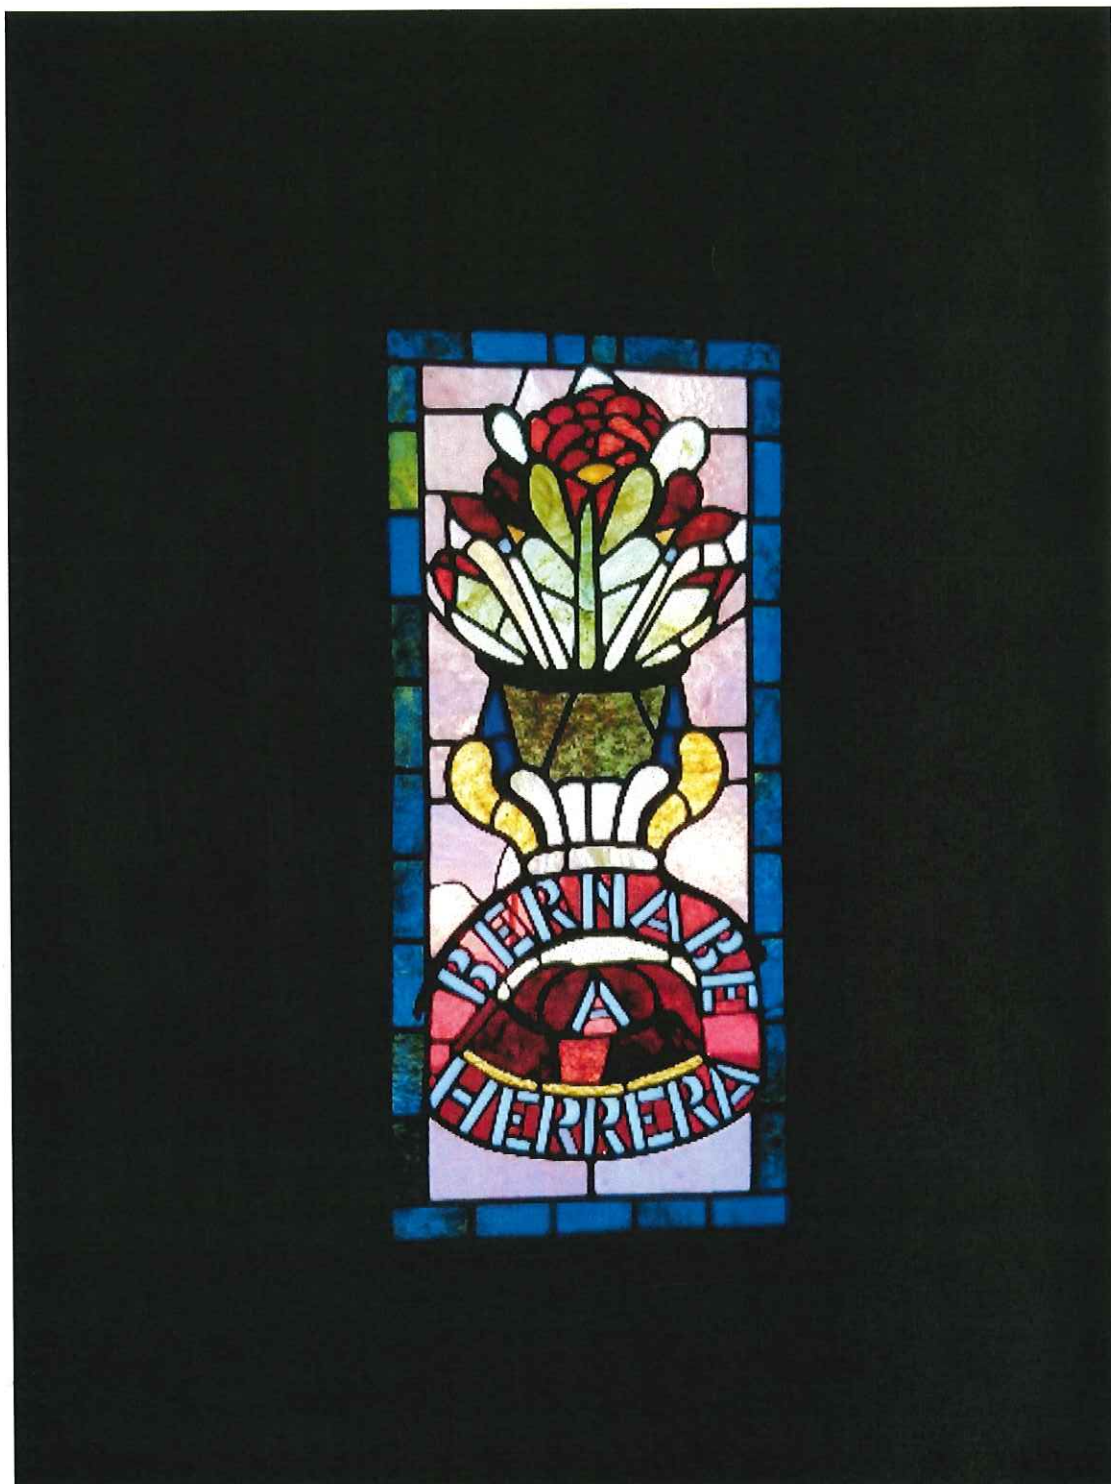
Photograph 2 of 17

2 of 17. Original stained-glass windows: this the signature window of Bernabé Herrera, the original maker of the stained-glass windows.

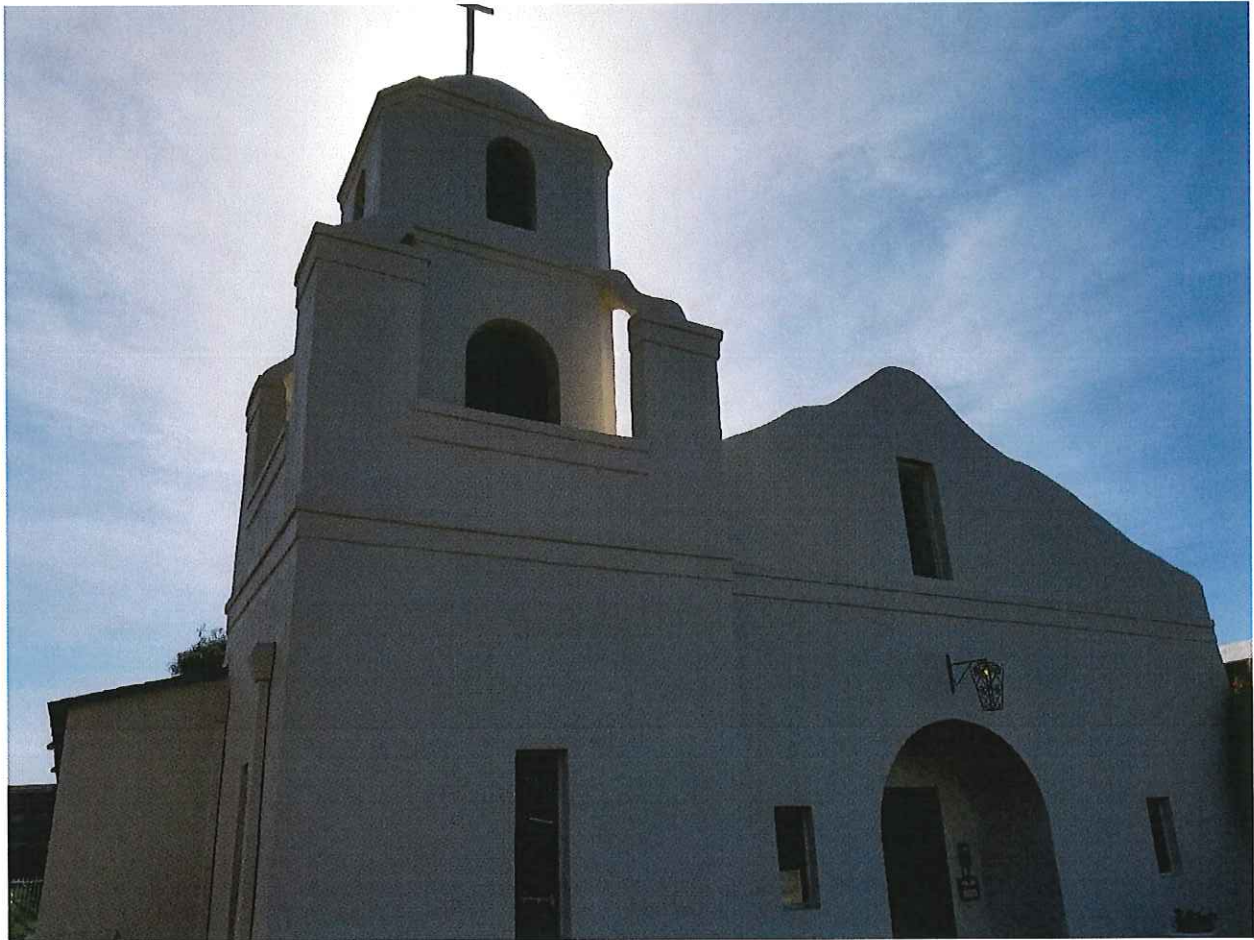
Photograph 6 of 17

6 of 17. View of the curvilinear parapet, wrought iron chandelier lighting feature, and original stained-glass window, all above the entrance's recessed round arch. The view is looking east.

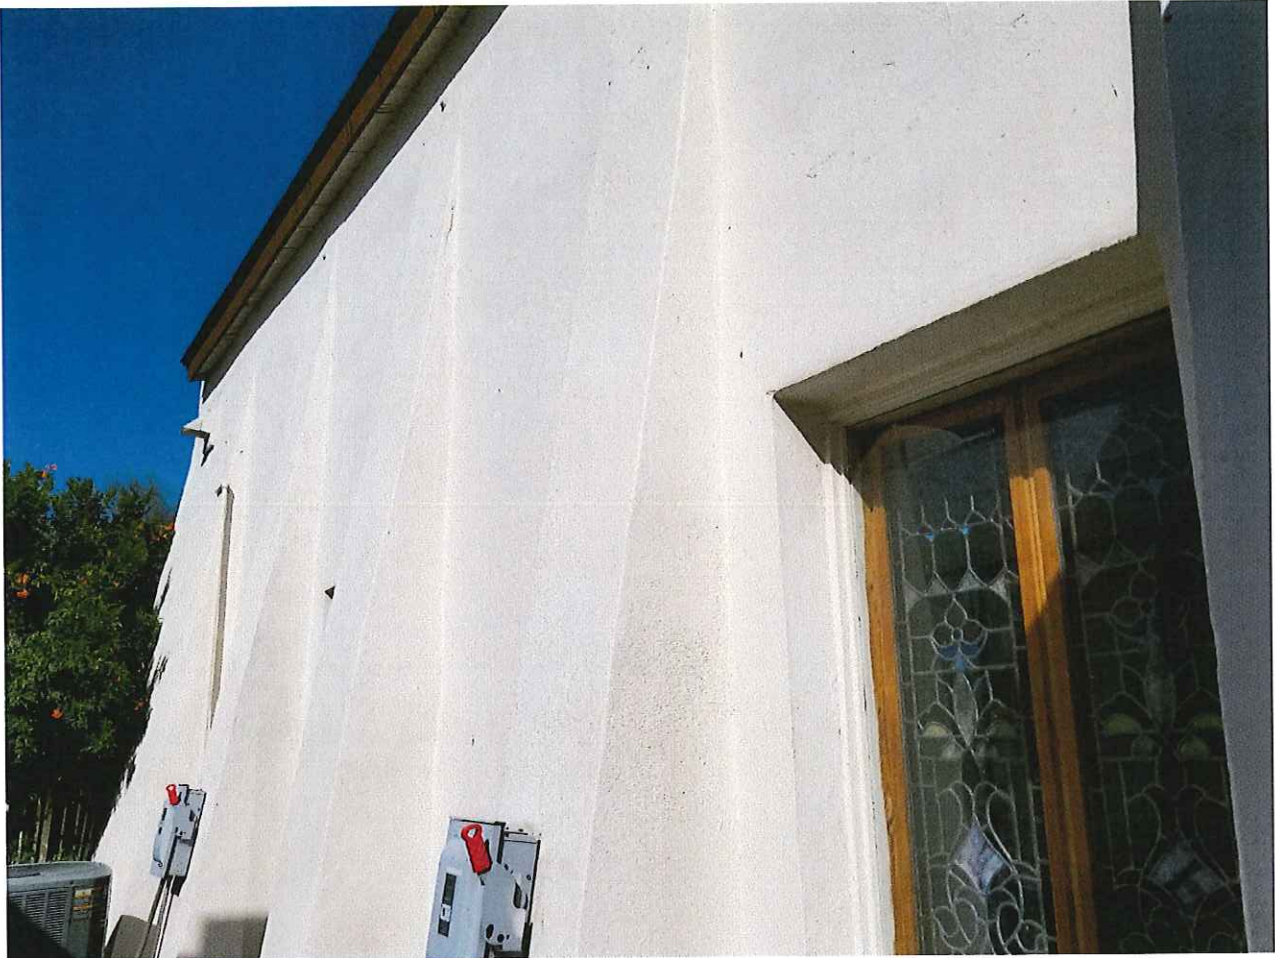
Photograph 11 of 15

11 of 17. Close-up of the south wall of the church featuring the buttresses that, together with the north wall buttresses support the pitched roof. One of the original stained-glass windows is visible, as well as two HVAC units. The view is looking west-northwest.

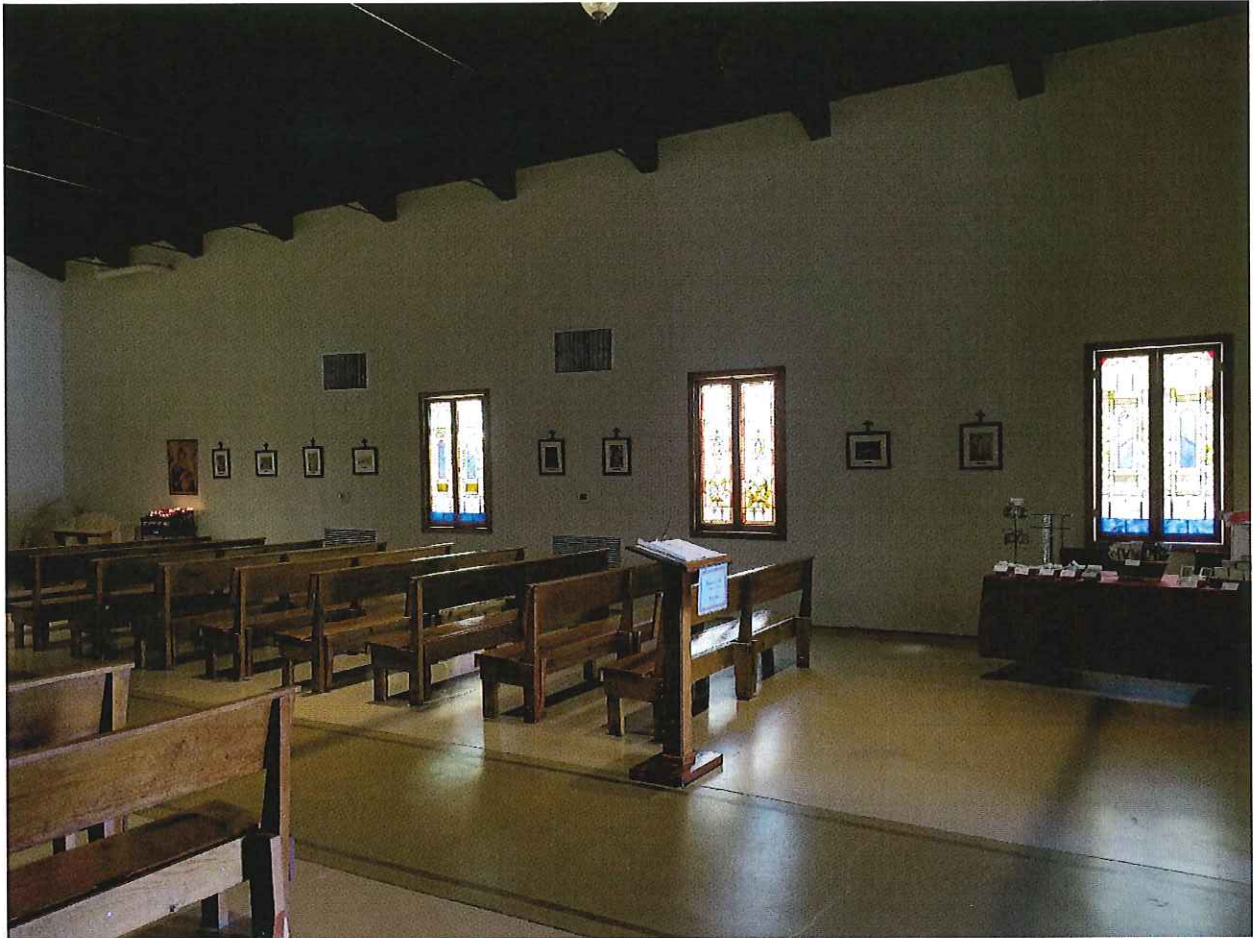
Photograph 17 of 17

17 of 17. Interior view of the south side wall featuring three stained glass windows and Sales Table.
